Date: June 17, 2024
To: HyG Homes, LLC
Attn: Adrian Tames
RE: Heron Valley U1&2 Condition Assessment Summary Report and Recommendations
Proj: TMS9377

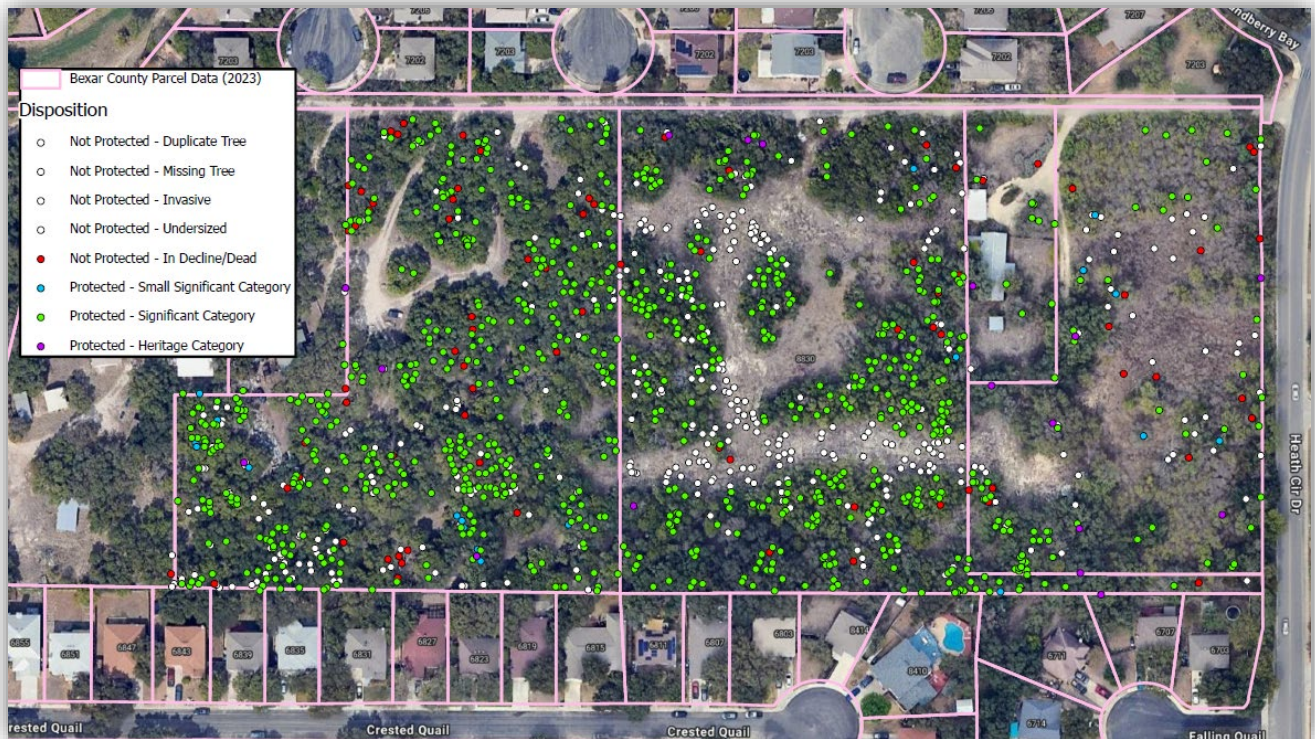
1,345 assessed tree points in various colors reflecting disposition category
