Report No: PRR:03113615-5

Proofroll Report

Client: ASHTON WOODS
17319 SAN PEDRO
SUITE 140
SAN ANTONIO, TX 78232

Project: ECHTLE SUBDIVISION UNIT 1
SAN ANTONIO, TX 78252

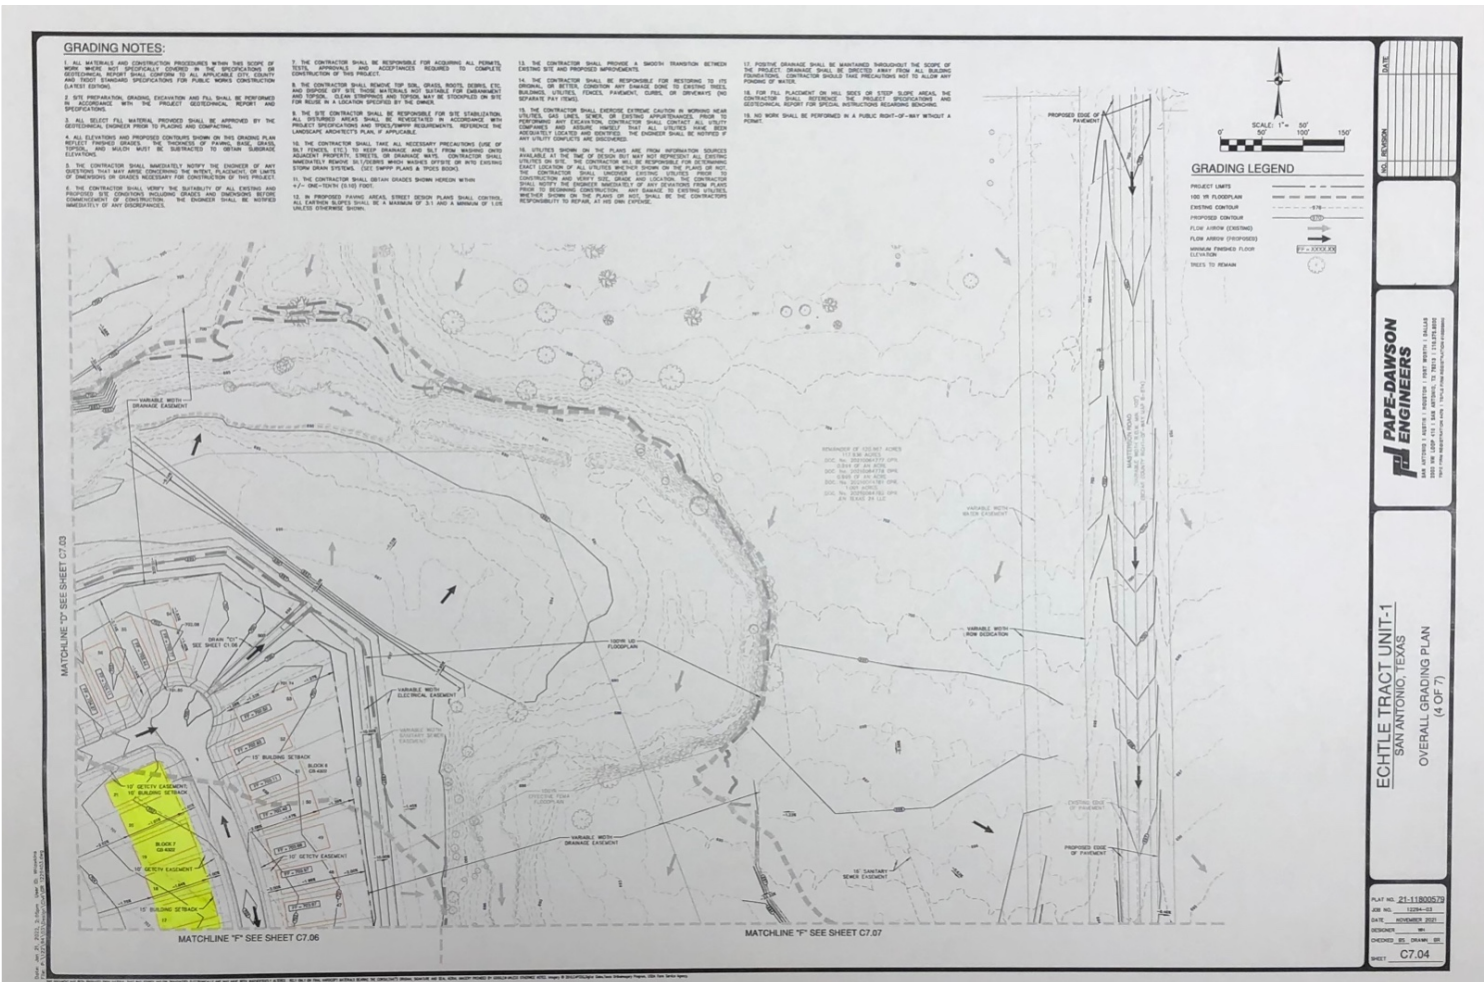
Drawing C7.04

Based on our observations, the Block 7, Lots 13-21 - Mixed Brown & Gray Lean Clay identified in this report IS considered suitable for intended purposes at this time.
