Project No. ANA23-022-00 (AND24-029-00)
January 23, 2026

**RE: Supplemental Letter
Precinct 18-1 Cut Wall
Veramendi Master Planned Development
New Braunfels, Texas**

Veramendi Precinct 18 Unit 1 Cut Wall

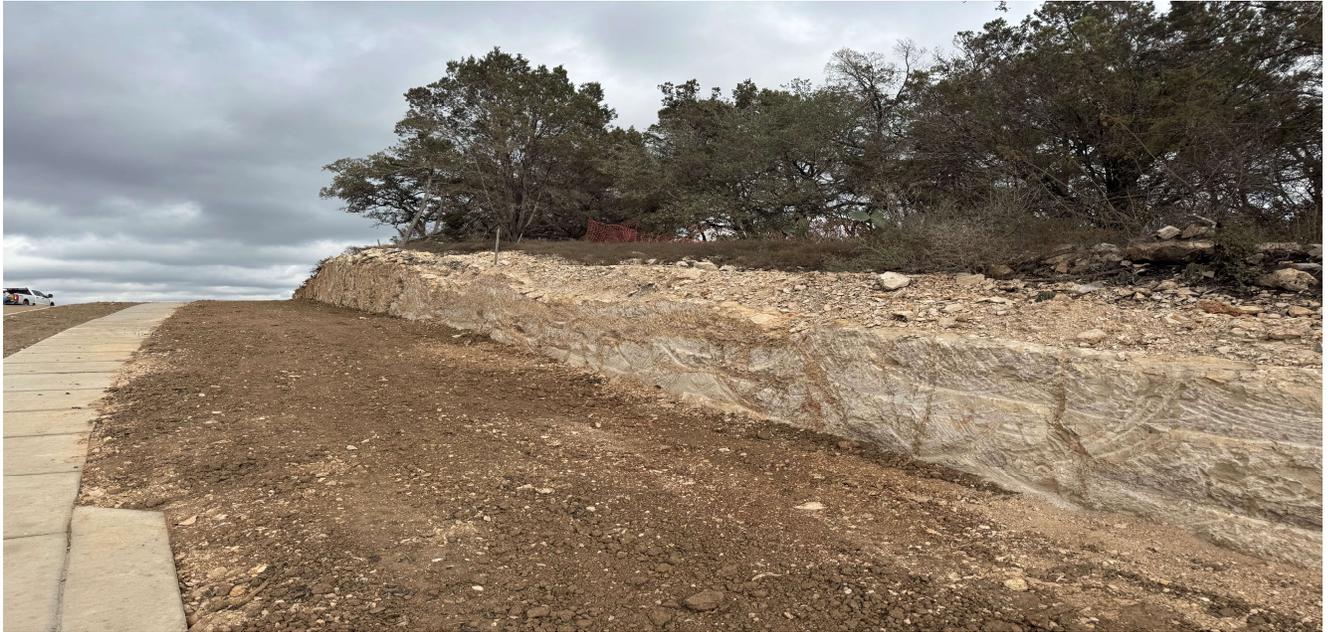
**PHOTOGRAPH 1
PHOTOGRAPH OF CUT WALL
PHOTOGRAPH TAKEN BY RKI ON DATE JANUARY 21, 2026**

Based on our review of the exposed cut wall conditions – including the site plan, elevation and nearby boring logs (Boring B-7), it is our opinion that the cut wall is currently stable from a slope-stability perspective and may not require supplemental support or retention in order to stand vertical or near vertical. The observed cut wall currently exhibited no signs of instability, adverse discontinuities or raveling that would necessitate structural retention. However, this site is underlain by the Edwards Limestone formation which is typically karstic and may have variable degrees of weathering (i.e. fractures, voids, clay filled voids, caves, weathered material, or other solution features) which makes it prone to raveling over time.

If the cut is left unprotected or unsupported, we recommend an adequate catchment/buffer area be provided at the toe to prevent rockfall from affecting adjacent improvements. A flat catchment area should be at least 0.5 times the height in width. In areas where adequate catchment cannot be provided due to right-of-way or other geometrical constraints, the slope should be protected from raveling and

differential erosion or laid back at a 1 Vertical to 1 Horizontal slope, or flatter. In addition to these protective measures, seepage, and surface water control to prevent stormwater from flowing over and down the face of the cut are essential in minimizing raveling and erosion. Note that leaving the cut unprotected may also require additional maintenance in the catchment/buffer area.
