**GEOTECHNICAL  
ENGINEERING STUDY**

**BRIGGS RANCH  
BEXAR COUNTY, TEXAS  
PAVEMENT DESIGN**

**FROST GEOSCIENCES, INC. PROJECT NO.: FGS-G 21118**

**NOVEMBER 23, 2021**

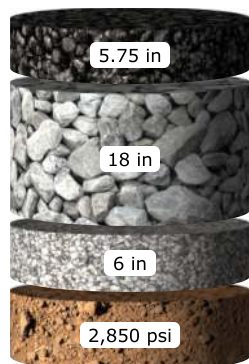
### TriAx Stabilized Pavement Section

| | Thickness | Coeff. | SN |
|---|---|---|---|
| Structural number (SN) | 5.430 | | |
| Calculated traffic (ESALs) | 2,022,100 | | |

**Geogrid** – **Tensar TX7** geogrid may be used to provide additional structural support to flexible base materials. The geogrid should be placed as per manufacturer's recommendations at the interface between the flexible base and subgrade.
