**GEOTECHNICAL INVESTIGATION
PAVEMENT THICKNESS
RECOMMENDATIONS**

**George's Ranch
Boerne, Texas**

July 2021

Engineer's Job # 21201100.010

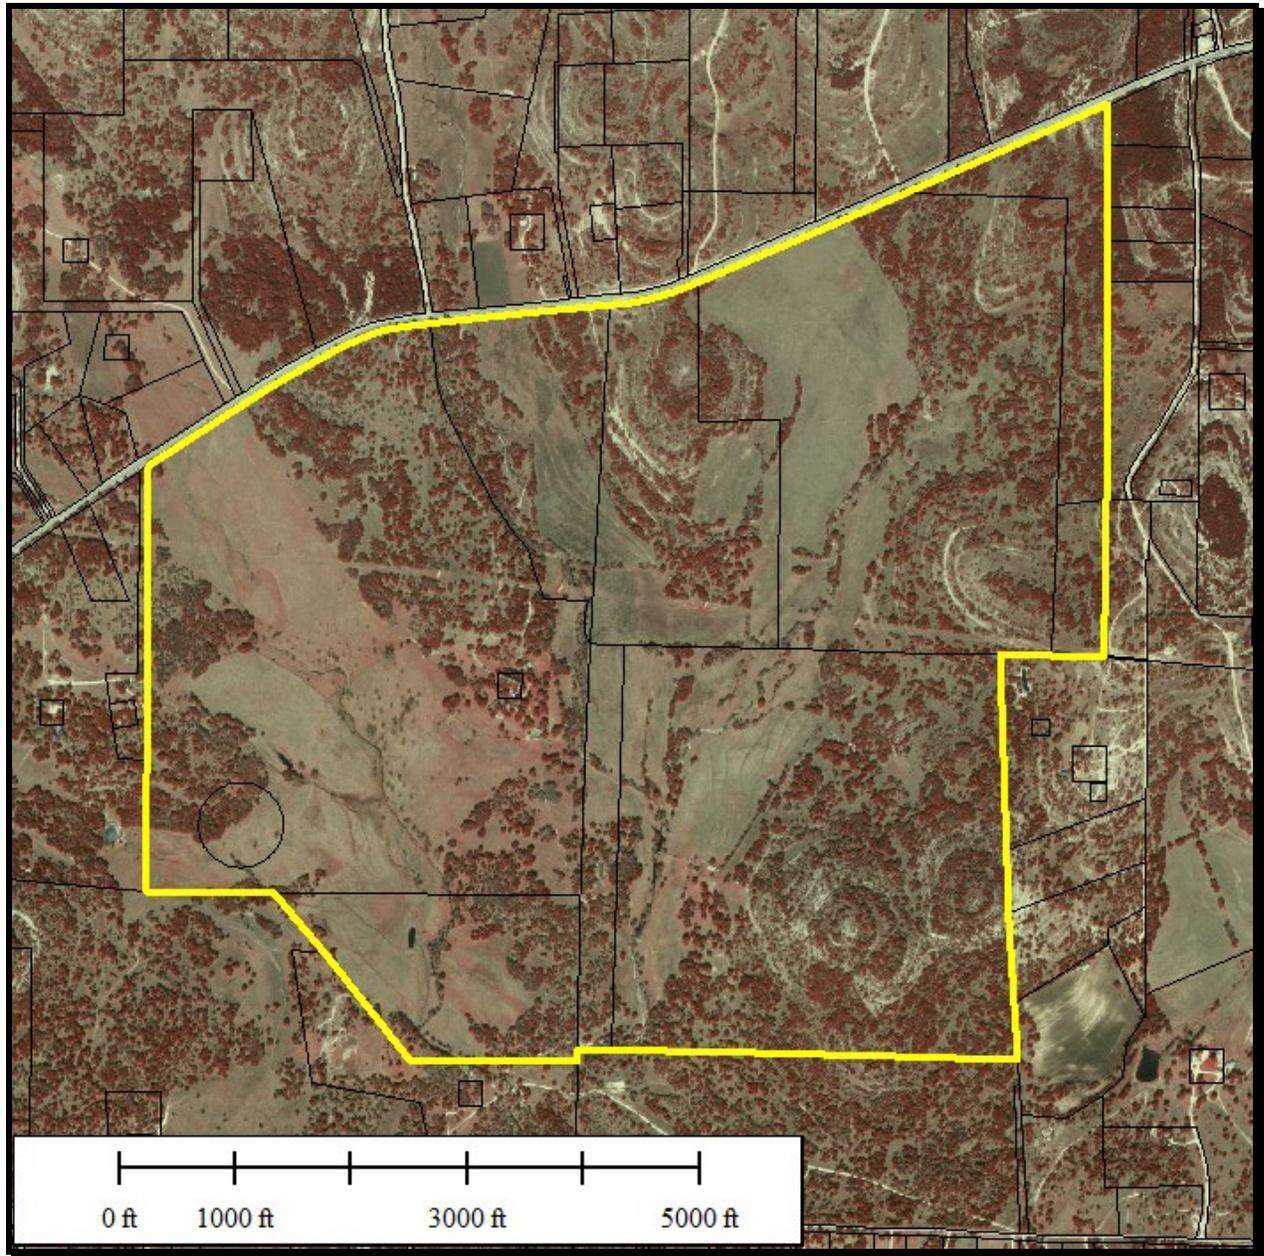
NAPP Aerial Photograph of Site – 1995

**Approximate location of site in yellow
Kendall County Parcels (2019) in black**

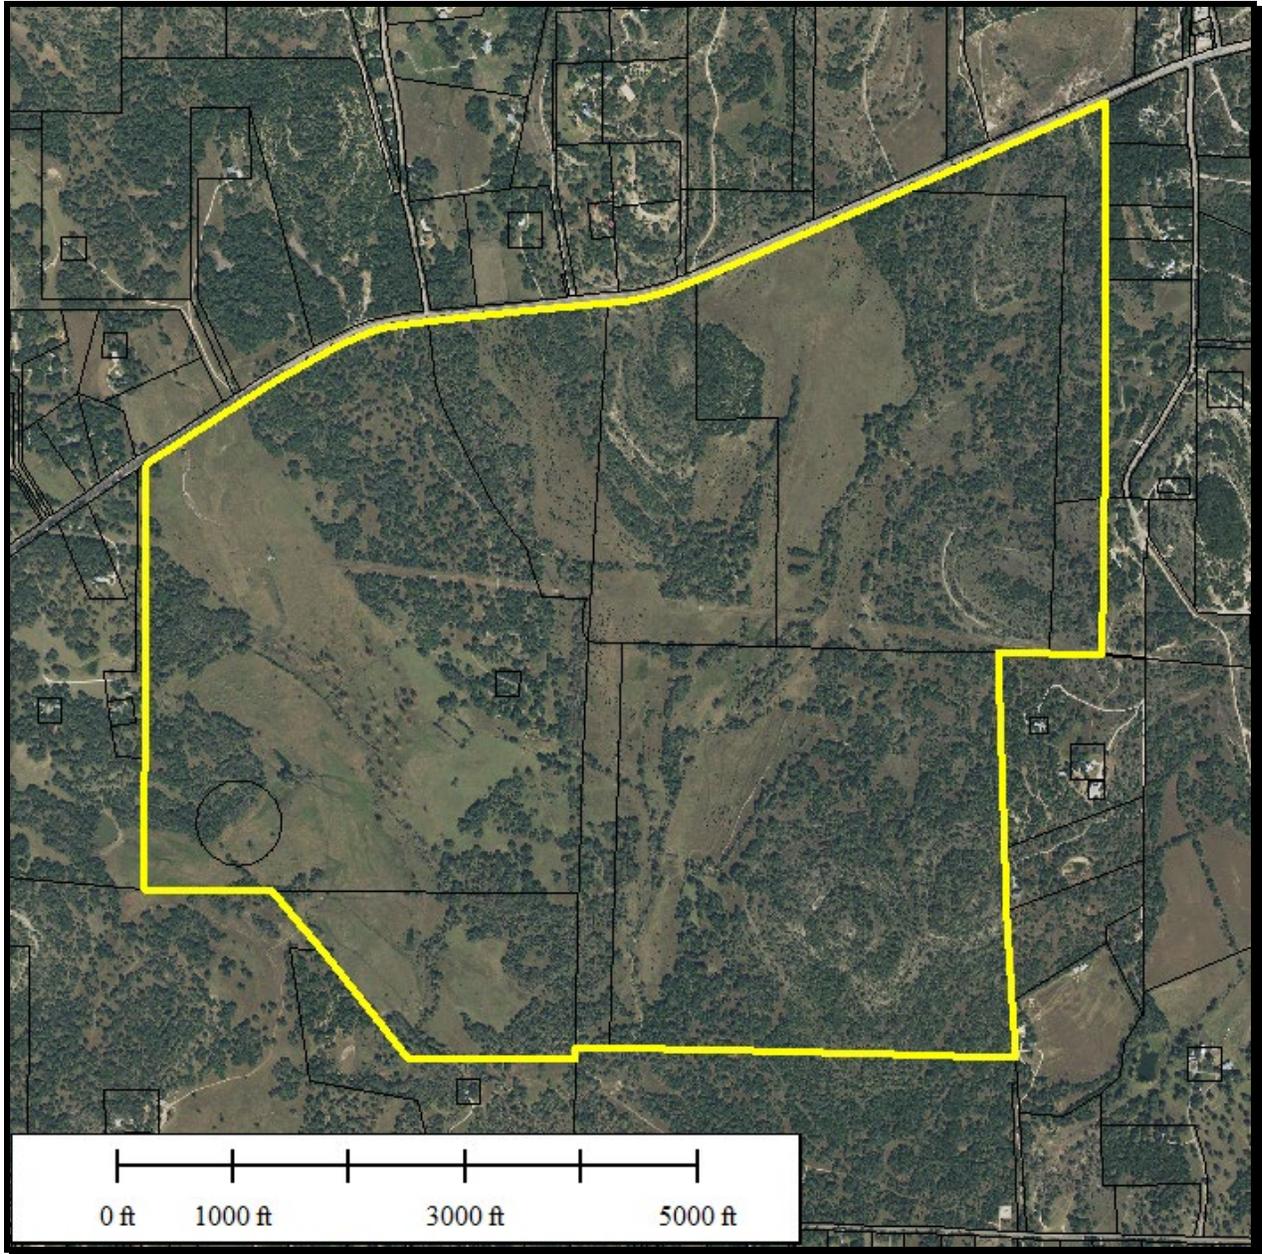
Aerial Photograph of Site – 2018

**Approximate location of site in yellow
Kendall County Parcels (2019) in black**

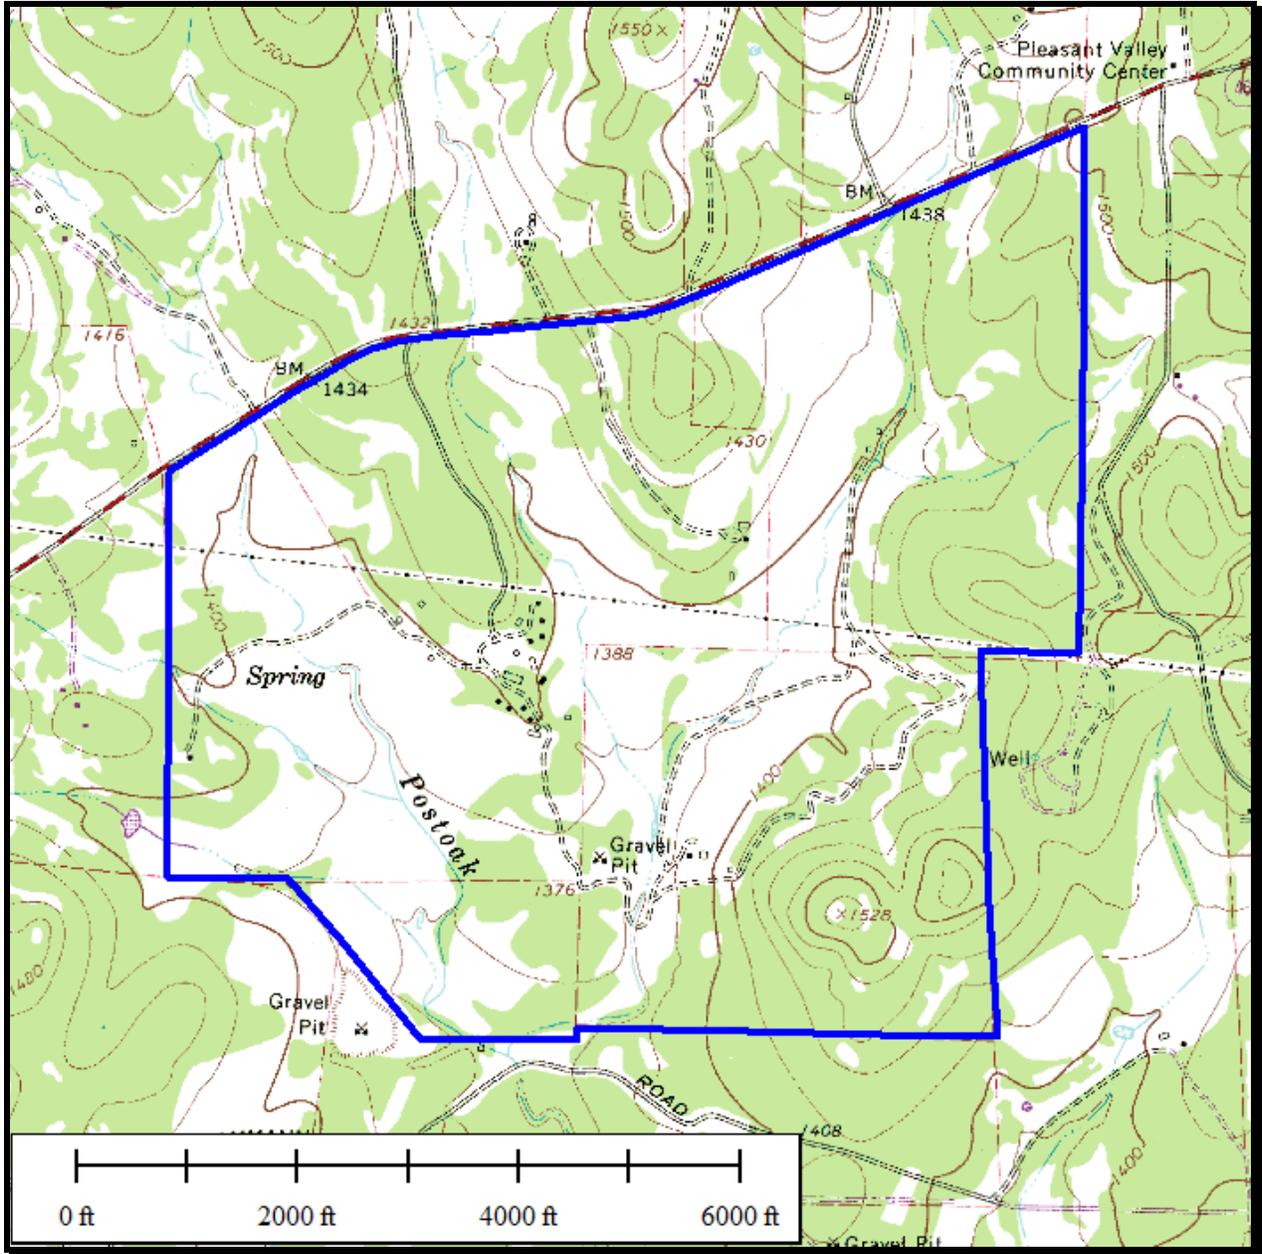
**U.S. 7.5 Minute Series Topographic Map
Boerne Quadrangle, Texas**

Approximate location of site in blue

1. Based on the "U.S. 7.5 Minute Series Topographic Map" in *Appendix A*, a gravel pit is located in the vicinity of Test Pit TP-54. This area should be thoroughly investigated with additional borings or test pits in order to determine the depth, extent, and contents of the gravel pit prior to pavement or foundation construction.
2. The subgrade improvement should be extended 12 inches beyond the back of the curb line.
3. These pavement thickness designs are intended to transfer the load from the anticipated traffic conditions.
4. The responsibility of assigning street classification to the streets in this project is left to the civil engineer.
5. If pavement designs other than those listed above are desired, please contact MLA Geotechnical.

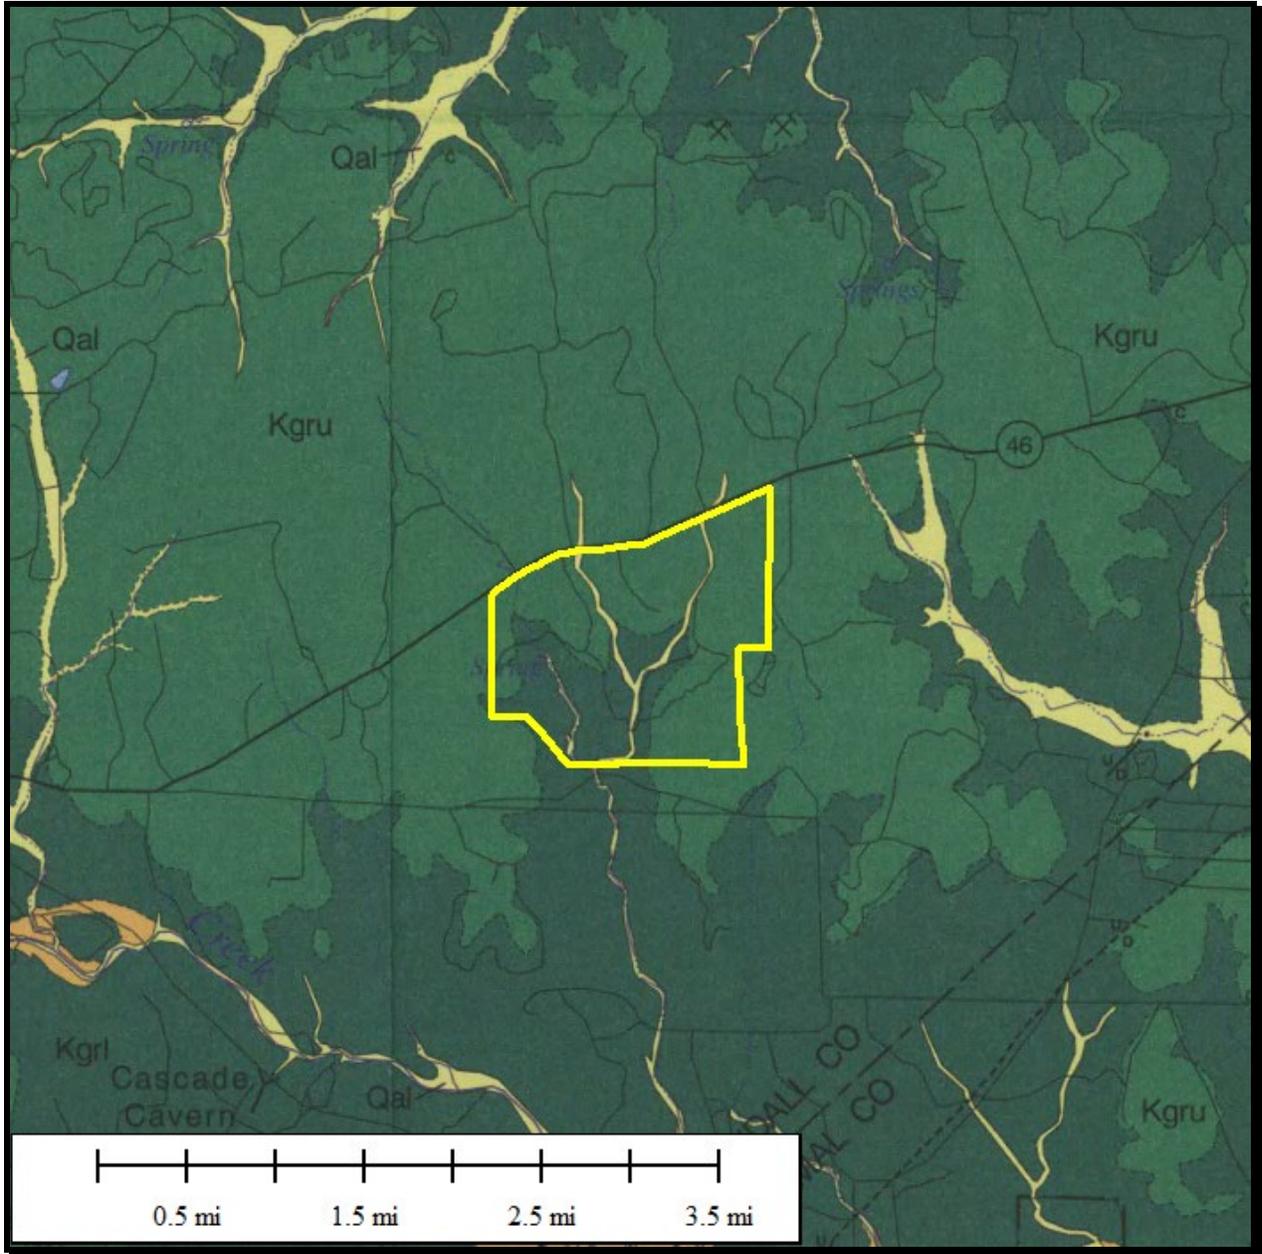
Geologic Setting of Site
Geologic Map of the New Braunfels, Texas, 30 x 60 Minute
Quadrangle (2000)

Approximate location of site in yellow

The Upper Glen Rose Formation, *Kgru*, and Lower Glen Rose Formation, *Kgrl*, are the youngest formation of the Trinity Group from Lower Cretaceous Period and its outcrop forms a narrow prairie in the Austin area from Mt. Bonnell northwest to Burnet. Its outcrop is characterized by steep canyons and terraced or "staircase" topography on hillsides.

The Glen Rose is predominantly a limestone formation, typically consisting of thin to massively bedded, hard limestone strata alternating with clay, argillaceous limestone, and thin sandstone strata. The formation was deposited under neritic or near shore conditions and the various strata represent different depositional environments such as mud flats, lagoons, beaches, and shallow water reefs. The alternating hard and soft layers cause the characteristic staircase topography of the Glen Rose.

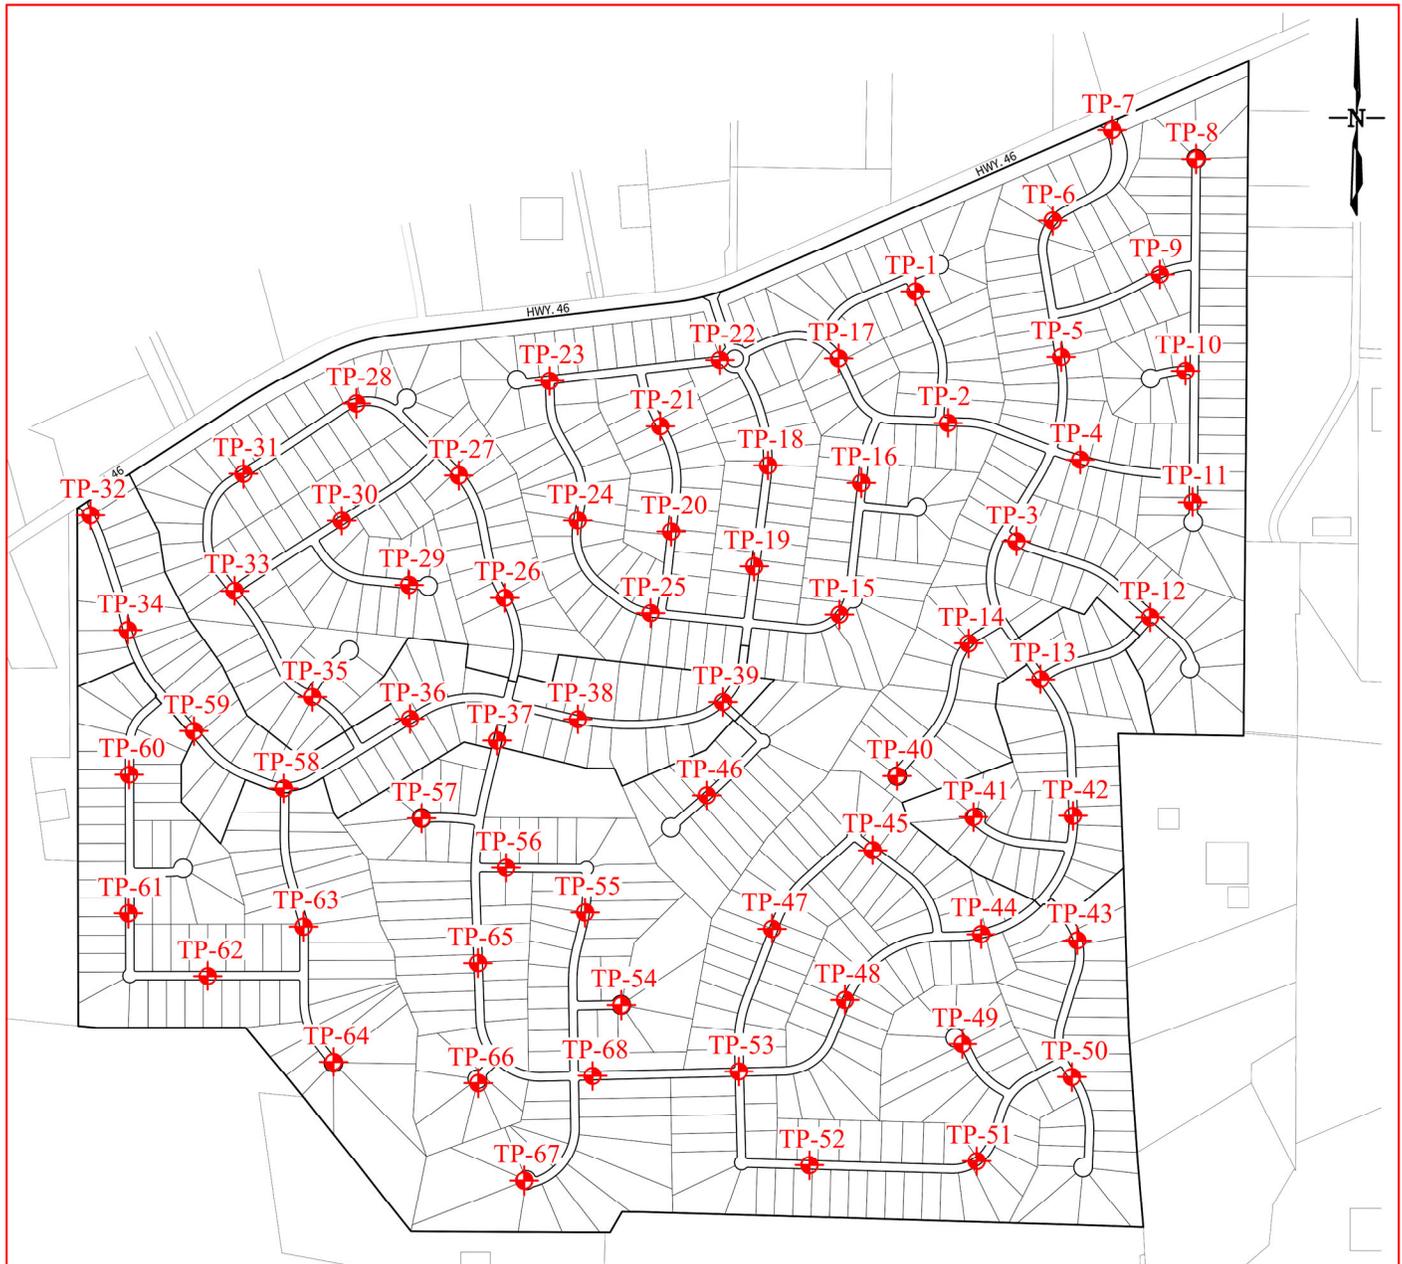
VICINITY MAP

| | Approx. Test Pit Location |

Sixty-eight test pits were excavated to various depths spaced at locations as shown on the enclosed Logs of Test Pits and Plan of Test Pits using a backhoe. Water was not introduced into the test pits. The field investigation included completing the soil test pits, performing field tests, and recovering samples. Representative soil samples were selected for laboratory index tests including Atterberg Limits and moisture content tests. The results of these tests and stratigraphy are presented on the Logs of Test Pits found in *Appendix A*. A key to the Soil Classification and symbols is located behind the last Log of Test Pits. See *Appendix B* for details of field and laboratory procedures, as applicable.
