Construction Materials Testing  
**Waterline Installation—Backfill Compaction**  
**Miralomas Garden Homes Unit 3**  
**Kendall County, Texas**

**InTEC Project No. S242024-2**  
January 7, 2026

**Re: Construction Materials Testing**  
**Waterline Installation – Backfill Compaction**  
**Miralomas Garden Homes Unit 3**  
Kendall County, Texas

**InTEC Project #: S242024-2**

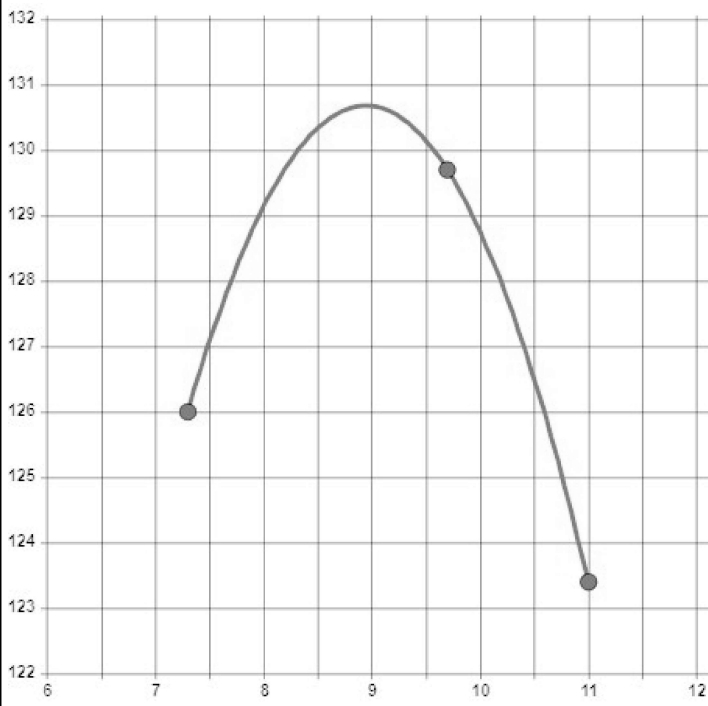
**Proctor Curve:**

**Test Method:** ASTM D1557 - Method C

**Maximum Dry Density (pcf):** 130.7

**Optimum Moisture (%):** 8.9

**Soil Classification:** GC Gravelly Clay
