Subsurface Exploration and Laboratory Testing
Tierra Linda Subdivision
San Antonio, Texas

InTEC Project Number:
S231273

Date:
10/13/2023

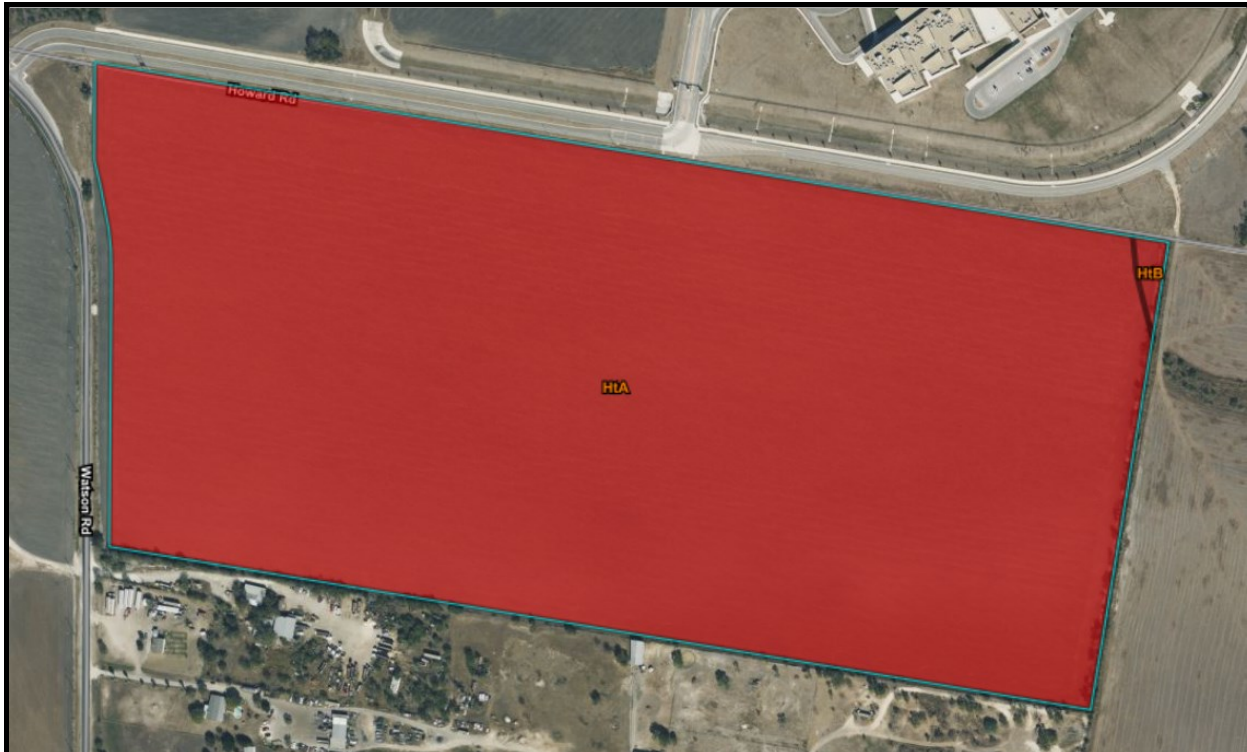
Soil Map—Approximate Location

Bexar County, Texas

Map unit symbol and soil name	Pct. of map unit	Hydrologic group	Depth	USDA texture	Classification		Pct Fragments		Percentage passing sieve number—				Liquid limit	Plasticity index
					Unified	AASHTO	>10 inches	3-10 inches	4	10	40	200		
			<i>In</i>				<i>L-R-H</i>	<i>L-R-H</i>	<i>L-R-H</i>	<i>L-R-H</i>	<i>L-R-H</i>	<i>L-R-H</i>	<i>L-R-H</i>	<i>L-R-H</i>
HTA—Branyon clay, 0 to 1 percent slopes														
Branyon	85	D	0-12	Clay	CH	A-7-6	0- 0- 0	0- 0- 0	94-96-100	78-92-100	73-90-100	64-79-92	59-63-69	35-39-43
			12-72	Clay, silty clay	CH	A-7-6	0- 0- 0	0- 0- 0	95-96-100	78-92-100	69-90-100	62-82-94	59-69-74	39-43-47
			72-80	Silty clay, silty clay loam, clay loam, clay	CH, CL	A-7-6, A-6	0- 0- 0	0- 0- 0	95-96-100	79-92-100	65-91-100	60-85-97	40-60-64	23-34-47
HTB—Branyon clay, 1 to 3 percent slopes														
Branyon	85	D	0-12	Clay	CH	A-7-6	0- 0- 0	0- 0- 0	94-96-100	78-92-100	73-90-100	64-79-92	59-63-69	35-39-43

12-72	Clay, silty clay	CH	A-7-6	0- 0- 0	0- 0- 0	95-96-100	78-92-100	69-90-100	62-82-94	59-69-74	39-43-47
			72-80	Clay, silty clay, silty clay loam, clay loam	CH, CL	A-7-6, A-6	0- 0- 0	0- 0- 0	95-96-100	79-92-100	65-91-100	60-85-97	40-60-64	23-34-47
