Construction Materials Testing  
**Waterline Installation—Backfill Compaction**  
**Rancho Carlota Unit 5**  
**San Antonio, Texas**

**InTEC Project No. S232015-2**  
January 16, 2024

Re: Construction Materials Testing  
**Waterline Installation – Backfill Compaction**  
**Rancho Carlota Unit 5**  
San Antonio, Texas

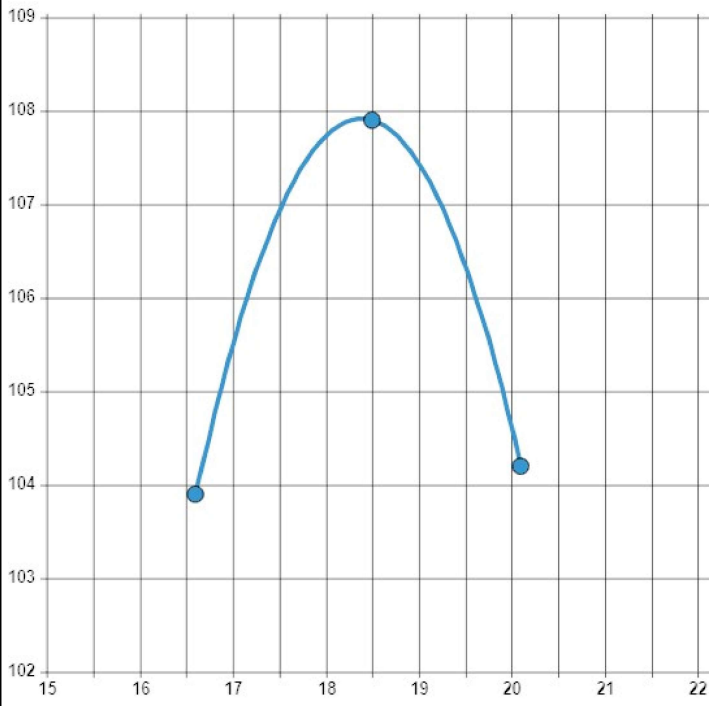
**Proctor Curve:**

**Test Method:** Tex 113E

**Maximum Dry Density (pcf):** 107.9

**Optimum Moisture (%):** 18.4
