**SUBJECT: SUBSURFACE EXPLORATION, LABORATORY TESTING PROGRAM,  
AND FOUNDATION AND PAVEMENT RECOMMENDATIONS  
FOR THE PROPOSED BANDERA RANCH TOWNHOMES  
15030 BANDERA ROAD  
HELOTES, TEXAS  
RETL Project Number: G222838**

**SUBSURFACE EXPLORATION, LABORATORY TESTING PROGRAM,  
AND FOUNDATION AND PAVEMENT RECOMMENDATIONS  
FOR THE PROPOSED  
BANDERA RANCH TOWNHOMES  
15030 BANDERA ROAD  
HELOTES, TEXAS**

**RETL PROJECT NUMBER: G222838**

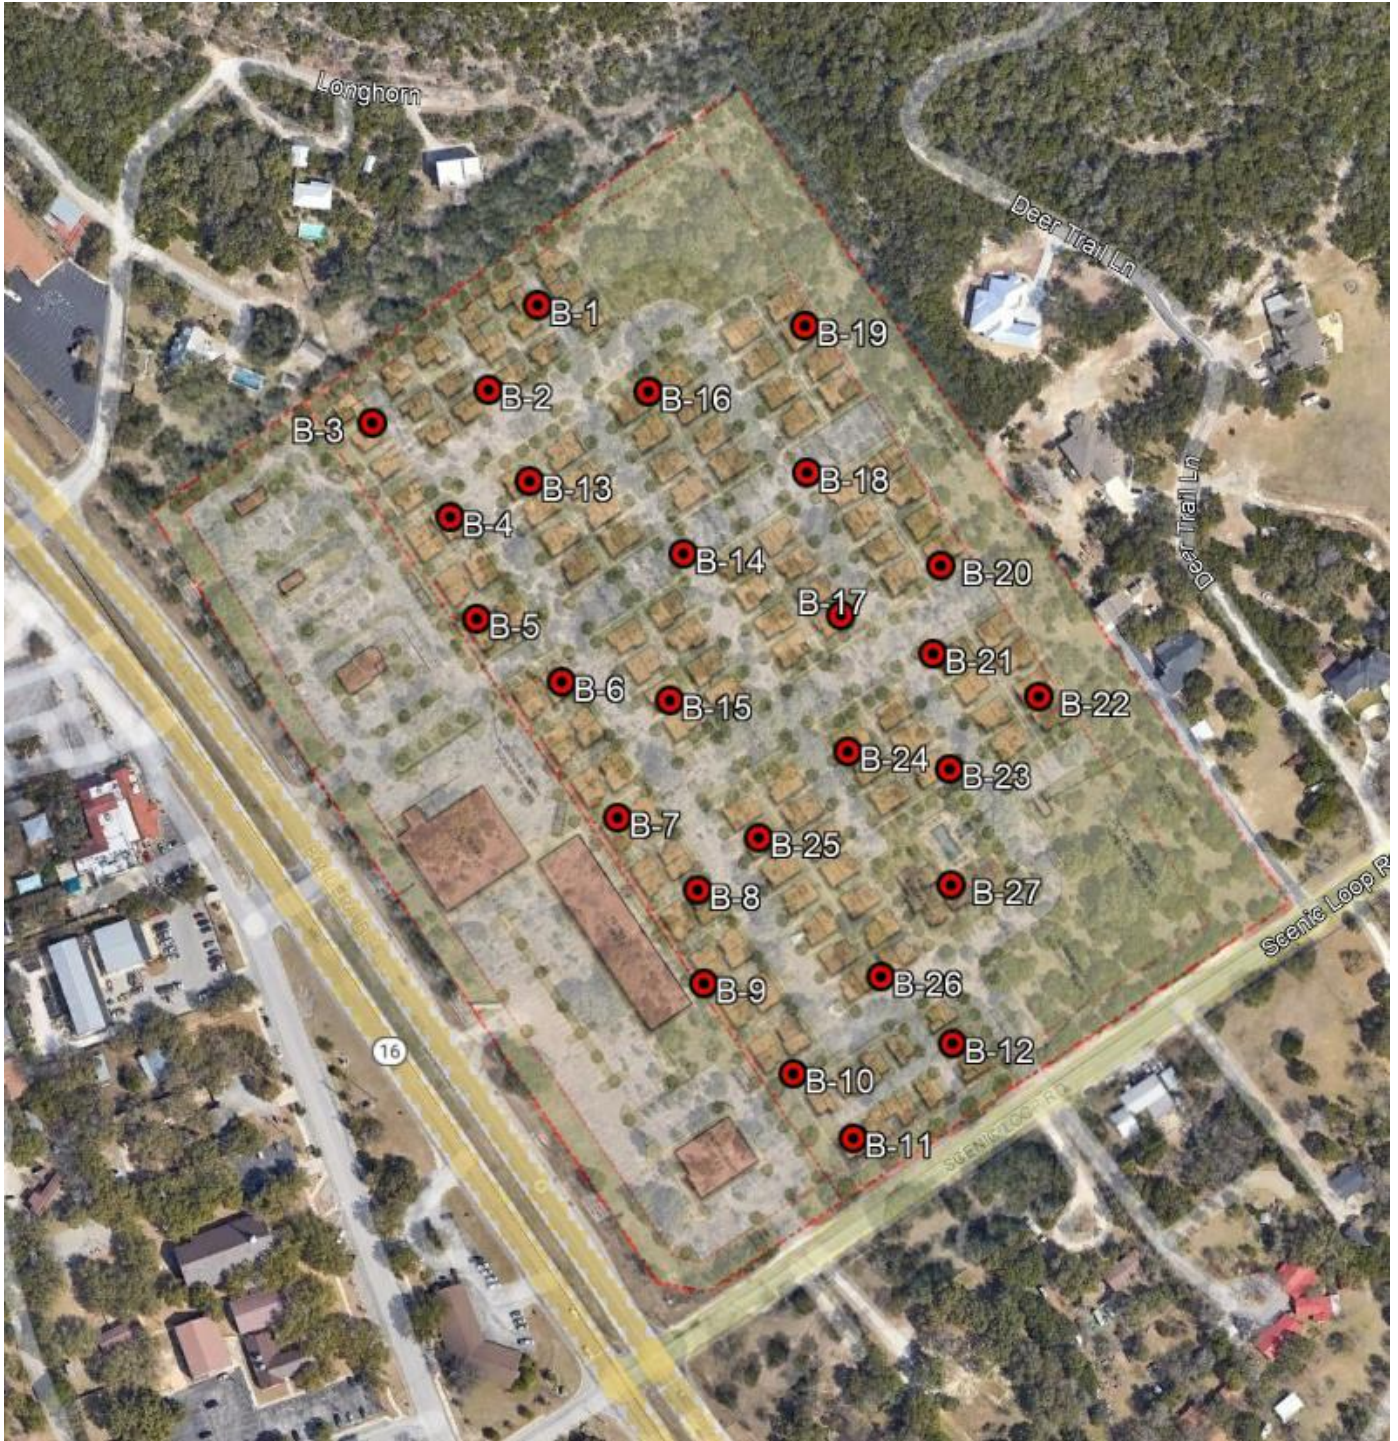
# BORING LOCATION PLAN

NO SCALE  
LOCATIONS ARE APPROXIMATE

The field exploration, completed in order to evaluate the engineering characteristics of the subsurface conditions, included a reconnaissance of the project site, drilling test borings and recovering disturbed samples of soil and rock at the test boring locations. RETL performed a total of twenty-seven (27) borings at the site. Each boring was drilled to a depth of approximately 20-feet.
