Construction Materials Testing  
**Sewerline Installation—Backfill Compaction**  
**Corley Farms Unit 2**  
**Boerne, Texas**

**InTEC Project No. S212189-1**  
November 3, 2023

**Re:** Construction Materials Testing  
Sewerline Installation – Backfill Compaction  
**Corley Farms Unit 2**  
Boerne, Texas

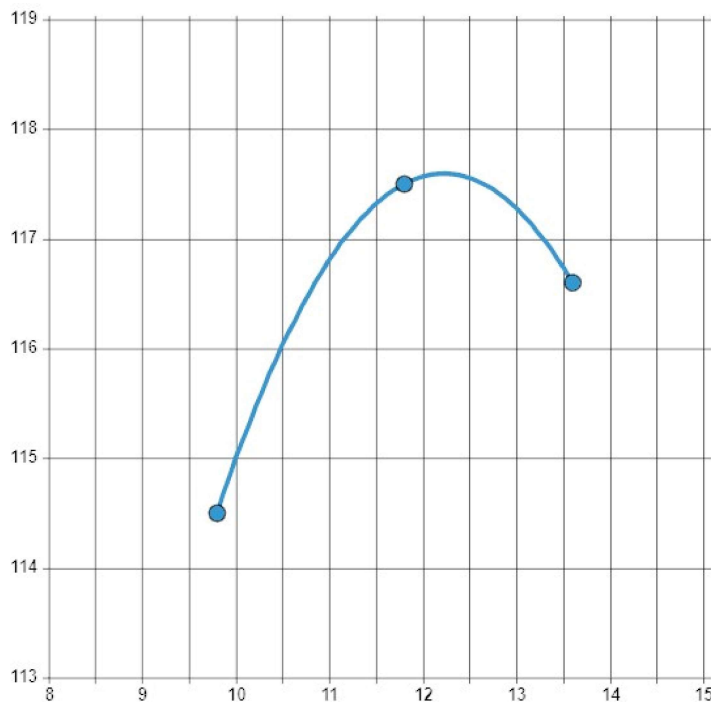
**Test Method:** ASTM D1557 - Method C**Proctor Curve:**

**Maximum Dry Density (pcf):** 117.6**Optimum Moisture (%):** 12.2**Soil Classification:** CH Clay with gravel**Test Completed Date:** 10/06/2022**Test Completed By:** Efediya, Eugene
