**Subsurface Exploration and Pavement Analysis
Proposed New Streets
Stolte Ranch Subdivision
San Antonio, Texas**

InTEC Project No. S191497-P
December 12, 2019

**Forestar (USA) Real Estate Group, Inc.
2221 E. Lamar Boulevard, Suite 790
Arlington, Texas 76006**

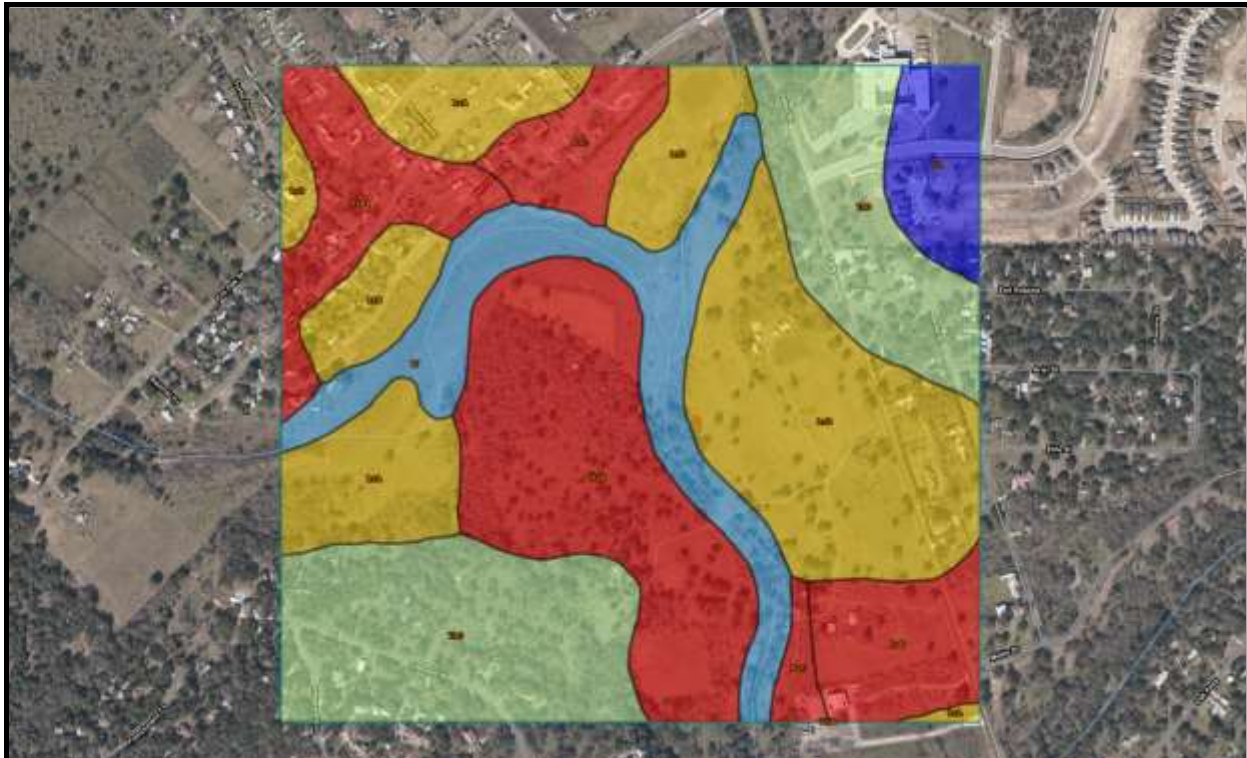
LdC—Lewisville silty clay, 1 to 2 percent slopes													
Lewisville	83	B	0-15	Silty clay	CH	A-7-E	0-0-0	0-0-0	94-99-100	94-99-100	91-93-100	52-53-59	20-28-34
			15-28	Silty clay loam, clay loam, silty clay	CL, CH	A-7-E, A-6	0-0-0	0-0-0	95-99-100	95-99-100	93-93-100	39-49-57	18-26-32
			28-60	Silty clay loam, clay loam, silty clay	CH, CL	A-7-E, A-6	0-0-0	0-0-0	91-99-100	91-99-100	91-93-100	39-50-59	18-27-34
PaB—Patrick soils, 1 to 2 percent slopes, rarely flooded													
Patrick	100	B	0-17	Clay loam	CL	A-6, A-7-E	0-0-0	0-1-2	75-92-95	75-92-95	81-79-90	36-43-49	12-22-28
			17-60	Very gravelly sand, very gravelly loamy sand	SC-GM, GM, GW-GM	A-1-A, A-1-B, A-2-A	0-0-0	2-14-25	28-38-50	29-32-45	10-18-25	8-14-20	18-21-25
PaC—Patrick soils, 2 to 5 percent slopes, rarely flooded													
Patrick	100	B	0-17	Gravelly clay loam	CL, SC, SC	A-6, A-7-E	0-0-0	0-2-3	70-78-83	69-72-78	39-45-75	36-43-49	12-22-28
