**Subsurface Exploration and Pavement Analysis
Proposed New Streets
Stolte Ranch, Unit 8
San Antonio, Texas**

InTEC Project No. S231061
March 24, 2023

InTEC Project No. S231061

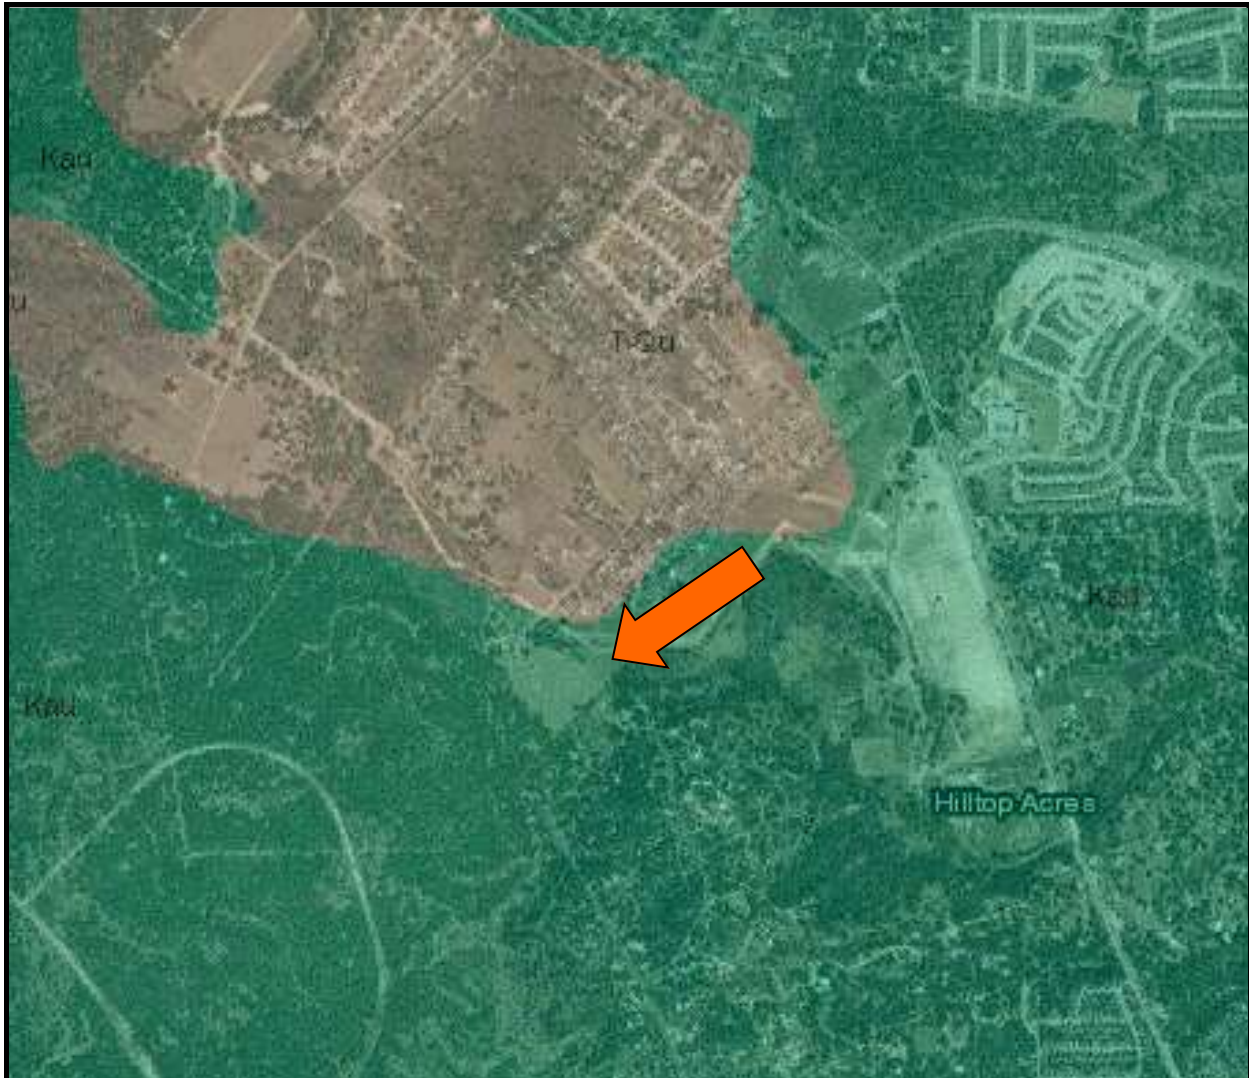
Kau - Austin Chalk

chalk and marl; chalk mostly microgranular calcite with minor foraminifera tests and Inoceramus prisms, averages about 85 calcium carbonate, ledge forming, grayish white to white; alternates with marl, bentonitic seams locally, recessive, medium gray, sparsely glauconitic, pyrite nodules in part feathered to limonite common, occasional beds with large-scale cross-stratification; locally highly fossiliferous; thickness 350-580 feet, thickens westward

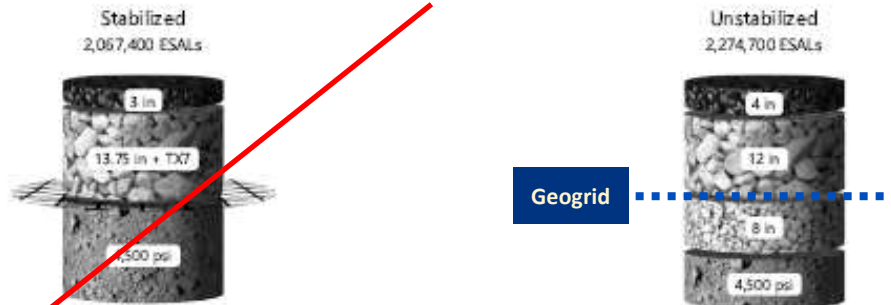
Results

Thickness	Coeff.	SN
HMA layer 1	3 in	0.420	1.260
Aggregate base (TX7)	13.75 in	0.227	3.121
Structural number (SN)			4.381

Thickness	Coeff.	SN
HMA layer 1	4 in	0.440	1.760
Aggregate base	12 in	0.170	2.040
Subbase	8 in	0.080	0.640
Structural number (SN)			4.440
