**Subsurface Exploration and Pavement Analysis
Proposed New Streets
Vista Gardens Subdivision
San Antonio, Texas**

InTEC Project No. S241319
December 12, 2024

Re: Subsurface Exploration and Pavement Analysis
Proposed New Streets
Vista Gardens Subdivision
San Antonio, Texas

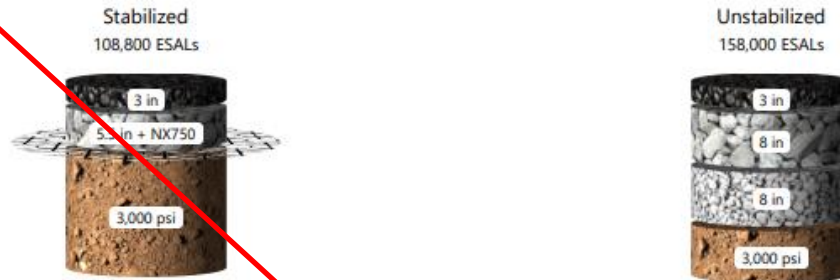
Results

Mechanically stabilized layer thickness less than 6 in is not recommended.

Thickness	Coeff.	SN
HMA layer 1	3 in	0.400	1.200
Aggregate base (NX750)	5.5 in	0.311	1.710
Structural number (SN)			2.910

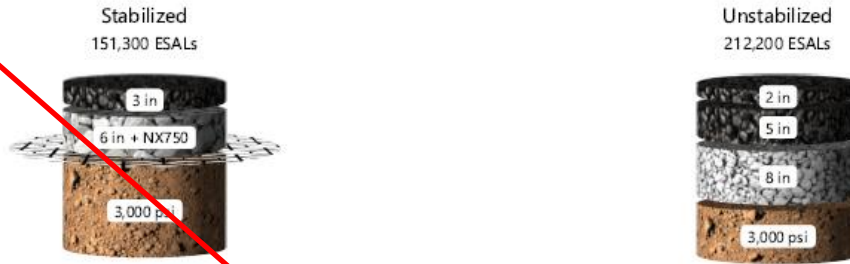
Results

Total HMA thickness should be within the same range on both pavement sections for accurate comparison: 2-3 in | 3-6 in | 6-14 in

Thickness	Coeff.	SN
HMA layer 1	3 in	0.420	1.260
Aggregate base (NX750)	6 in	0.300	1.800
Structural number (SN)			3.060
